## Site Information

## Soil Description

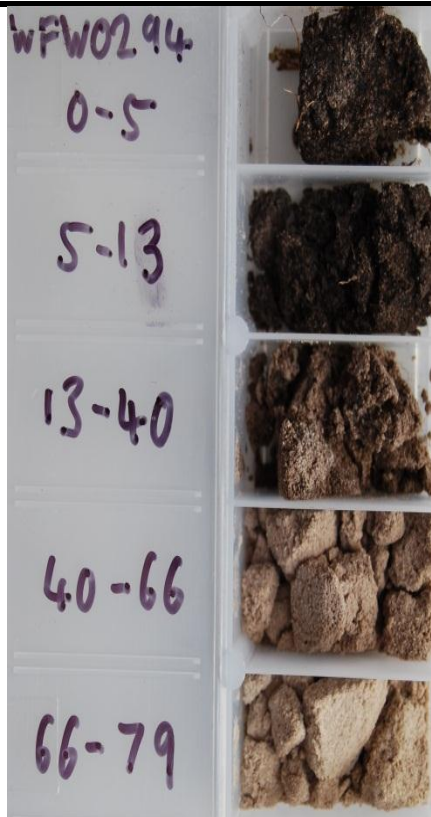
| A1 | 0 - 0.13 m | Black (10YR2/1-Moist); Sandy loam; Weak grade of structure, 2-5 mm, Polyhedral; Clear change to - |
| B1 | 0.13 - 0.4 m | Dark grey (7.5YR4/1-Moist); Loamy sand; Massive grade of structure; Clear change to - |
| B2 | 0.4 - 0.66 m | Brown (7.5YR4/2-Moist); Loamy sand; Massive grade of structure; Clear change to - |
| B3 | 0.66 - 0.79 m | Brown (10YR5/3-Moist); Loamy sand; Massive grade of structure; |
