# Soil Site Information Sheet

FLINDERS

FI041

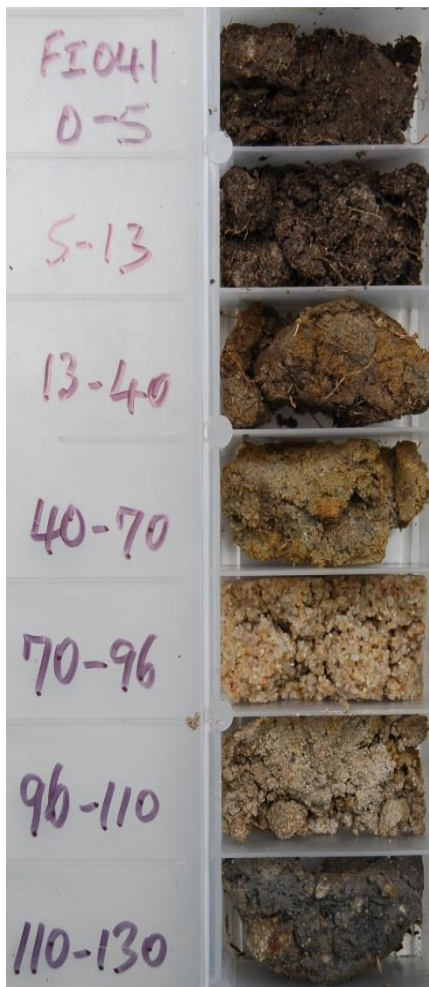
A1	0 - 0.13 m	Very dark greyish brown (10YR3/2-Moist); Very few (0-2%) mottles; Clay loam; Moderate grade of structure, 2-5 mm, subangular blocky;
B21	0.13 - 0.4 m	Greyish brown (2.5Y5/3-Moist); Common (10-20%) mottles; Light clay; Strong grade of structure, 10-20 mm, subangular blocky;
B22	0.4 - 0.7 m	Greyish brown (2.5Y5/2-Moist); Common (10-20%) mottles; Sandy light clay; Massive grade of structure;
B3	0.7 - 0.96 m	Light brownish grey (2.5Y6/3-Moist); Few (2-10%) mottles; Loamy coarse sand; Single grain grade of structure;
BC1	0.96 - 1.1 m	Light brownish grey (2.5Y6/2-Moist); Very few (0-2%) mottles; Coarse sandy light clay; Massive grade of structure; Common (10-20%), fine gravelly (2-6 mm), rounded, dispersed, very strong, coarse fragments; Soil matrix is highly calcareous;
BC2	1.1 - 1.3 m	Grey (5Y5/1-Moist); Very few (0-2%) mottles; Medium clay; Massive grade of structure; Soil matrix is slightly calcareous;
