Site Information

Soil Classification

Australian Soil Classification: Brown Chromosol
ASC Confidence: No analytical data and little or no knowledge of this soil.
Soil Name:

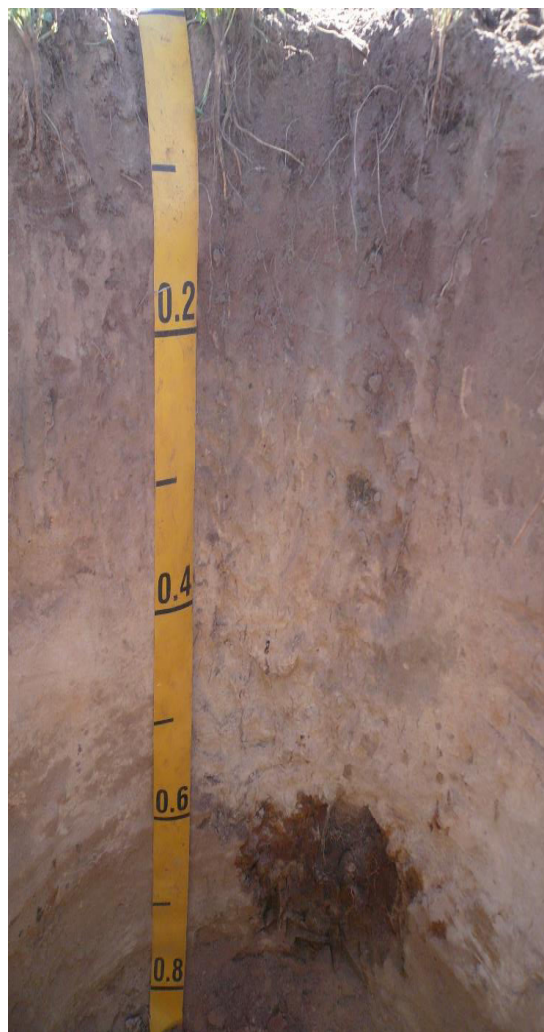
Morphological Description

Horizon	Depth	Description
A1	0 - 20cm	Dark greyish brown (10YR 4/2) moist sandy loam; moderate, 5-10 mm, moderate polyhedral structure; water repellent.
A21	20 - 40cm	Brown (7.5YR 5/4) moist; pale brown (10YR 6/3) dry loamy sand; weak structure; no mottles mottles; weakly cemented, silcrete pan.
A22	40 - 62cm	Pink (7.5YR 7/4) moist; white (2.5y 8/0) dry heavy sand; weak structure; moderately cemented, silcrete pan; few (2-10%), ferricrete medium gravelly (6-20mm).
B21	62 - 80cm	Brown (7.5YR 5/4) moist; strong brown (7.5YR 5/6) dry; many (20-50%), distinct mottles; many (>50% of ped faces or walls coated), slicken sides.
