Wealth from Water Site Information Sheet

WfW 0125

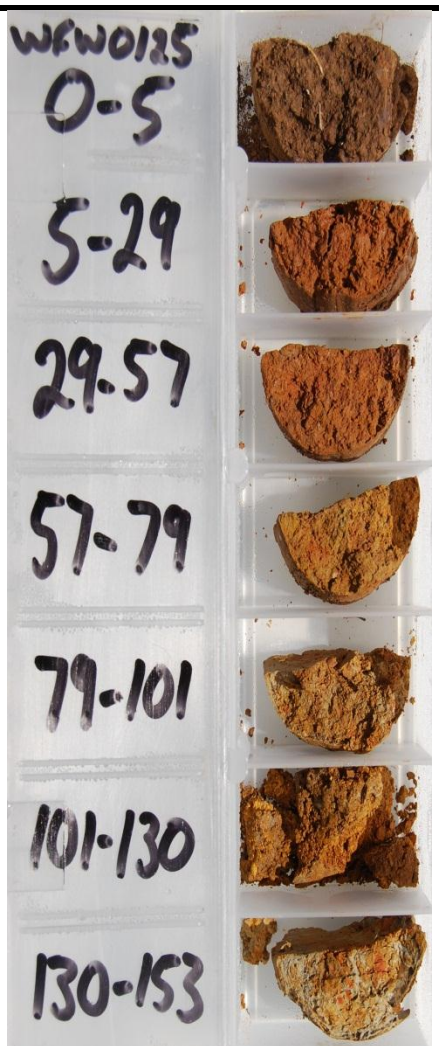
Soil Description

A1	0 - 0.08 m	Very dark greyish brown (10YR3/2-Moist); Medium clay; Moderate grade of structure, 2-5 mm;
B1	0.08 - 0.29 m	Dark yellowish brown (10YR4/6-Moist); Medium clay; Moderate grade of structure, 10-20 mm; Clear change to -
B21	0.29 - 0.57 m	Yellowish brown (10YR5/6-Moist); Mottles, 0-2%, ; Medium clay; Moderate grade of structure, 20-50 mm; Clear change to -
B22	0.57 - 1.01 m	Yellowish brown (10YR5/6-Moist); Mottles, 10-20%, ; Medium clay; Massive grade of structure; Clear change to -
B23	1.01 - 1.3 m	Dark yellowish brown (10YR4/6-Moist); Mottles, 10-20%, ; Medium clay; Massive grade of structure; 0-2%, Dolerite, coarse fragments; Clear change to -
B3	1.3 - 1.53 m	Light grey (10YR7/2-Moist); Mottles, 20-50%, ; Medium clay; Massive grade of structure;
