Wealth from Water Site Information Sheet

WfW 0137

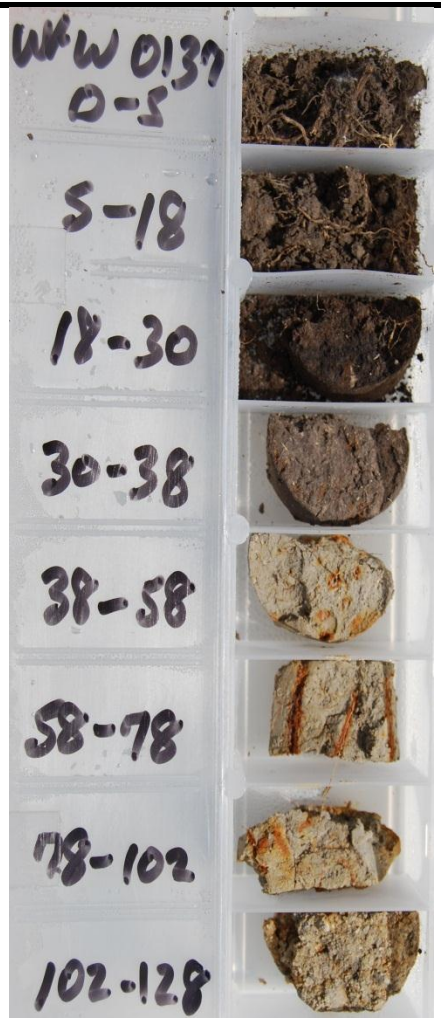
P11	0 - 0.18 m	(/-Moist); Sandy peat; Strong grade of structure, 5-10 mm, Angular blocky; Gradual change to -
P12	0.18 - 0.3 m	(/-Moist); Sandy peat; Strong grade of structure, 5-10 mm, Angular blocky; Abrupt change to -
A3	0.3 - 0.38 m	Grey (7.5YR5/1-Moist); Mechanical, 0-2%, 5-15mm, Faint; Light clay; Massive grade of structure; Clear
B1	0.38 - 0.78 m	Light brownish grey (2.5Y6/2-Moist); Mottles, 2-10%, 5-15mm, Prominent; Light clay; Massive grade of structure; Clear change to -
B2	0.78 - 1.02 m	Light brownish grey (2.5Y6/2-Moist); Mottles, 10-20%, 15-30mm, Prominent; Light clay; Massive grade of structure; Clear change to -
BC	1.02 - 1.28 m	Light brownish grey (2.5Y6/3-Moist); Mottles, 2-10%, 5-15mm, Distinct; Clayey sand; Massive grade of structure; 10-20%, fine gravelly, 2-6mm, subrounded, dispersed, Quartz, coarse fragments;
