Wealth from Water Site Information Sheet

WfW 0158

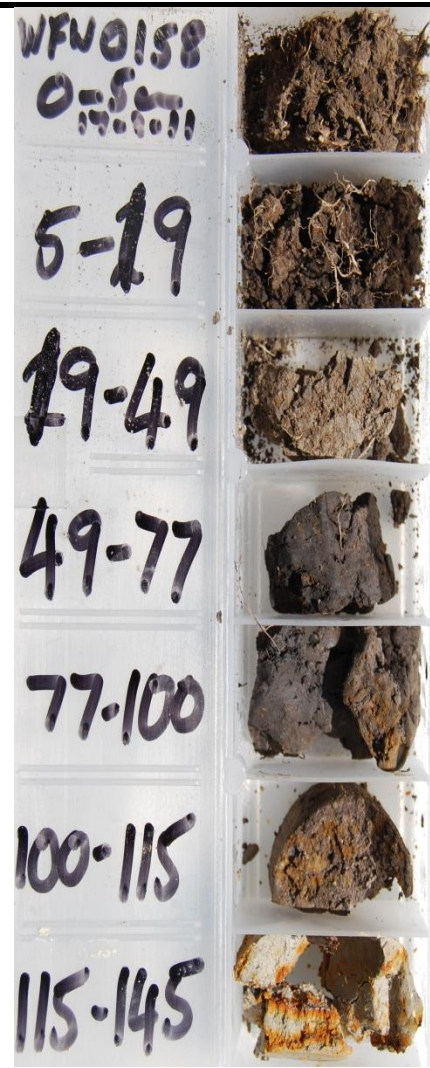
1A1	0 - 0.19 m	Black (10YR2/1-Moist); Clay loam; Strong grade of structure, 5-10 mm, Subangular blocky; Abrupt change to -
1B1	0.19 - 0.49 m	Dark grey (10YR4/1-Moist); Mottles, 2-10%, 5-15mm, Distinct; Clayey sand; Single grain grade of structure; Abrupt change to -
2A11	0.49 - 0.77 m	Black (10YR2/1-Moist); Mottles, 0-2%, 5-15mm, Faint; Light clay; Moderate grade of structure, 20-50 mm, Angular blocky; Gradual change to -
2A12	0.77 - 1 m	Dark grey (10YR4/1-Moist); Mottles, 0-2%, 15-30mm, Distinct; Light clay; Moderate grade of structure, 20-50 mm, Angular blocky; Gradual change
2B2	1 - 1.15 m	Dark grey (10YR4/1-Moist); Mottles, 2-10%, 15-30mm, Distinct; Fine sandy light clay; Massive grade of structure; Clear change to -
2B3	1.15 - 1.45 m	Grey (2.5Y6/1-Moist); Substrate influence, 2-10%, 15-30mm, Prominent; Fine sandy light clay; Massive grade of structure;

Site: No Inundation
 General: Profile Note: Looks like a buried profile starting at approx 49cm, caused possibly from past flooding and infilling (No Contemporary flooding evident).
