Wealth from Water Site Information Sheet

WfW 0327

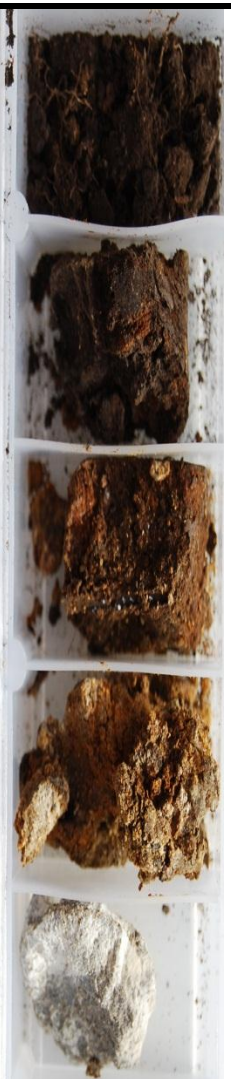
WfW 0327

0-5

5-13

13-43

43-73

A1	0 - 0.13 m	Black (10YR2/1-Moist); Clay loam; Strong grade of structure, 5-10 mm, Subangular blocky; 0-2%, fine gravelly, 2-6mm, subangular, dispersed, Dolerite, coarse fragments; Sharp change to -
B2	0.13 - 0.43 m	Brown (7.5YR4/3-Moist); Biological mixing, 2-10%, 5-15mm, Distinct; Light clay; Strong grade of structure, 20-50 mm, Angular blocky; 2-10%, medium gravelly, 6-20mm, subangular, dispersed, Dolerite, coarse fragments; Few cutans, <10% of ped faces or walls coated, faint; Clear change to -
B3	0.43 - 0.73 m	Strong brown (7.5YR5/6-Moist); Substrate influence, 2-10%, 15-30mm, Prominent; Sandy clay loam; Massive grade of structure; 2-10%, medium gravelly, 6-20mm, subangular, dispersed, Dolerite, coarse fragments; Few (2 - 10 %), Ferruginous, Nodules, Medium (2 -6 mm) segregations; Abrupt change to -
R	0.73 - m	Rock
