Wealth from Water Site Information Sheet

WfW 0615

Site Information

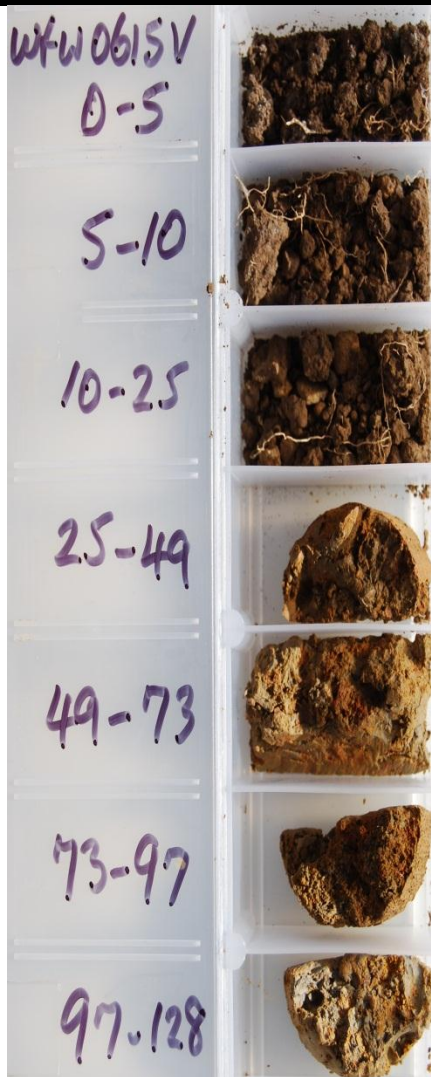
A1	0 - 0.1 m	Dark brown (10YR3/3-Moist); Clay loam; Strong grade of structure, 2-5 mm, Granular; 2-10%, fine gravelly, 2-6mm, subrounded, Shale, coarse fragments; Abrupt change to -
A3	0.1 - 0.25 m	Dark brown (10YR3/3-Moist); Clay loam; Strong grade of structure, 2-5 mm, Granular; 2-10%, fine gravelly, 2-6mm, subrounded, Shale, coarse fragments; Sharp change to -
B1	0.25 - 0.49 m	Yellowish brown (10YR5/4-Moist); Mottles, 10-20%, ; Heavy clay; Strong grade of structure, 20-50 mm, Prismatic; 0-2%, medium gravelly, 6-20mm, subangular, Shale, coarse fragments; Common cutans, 10-50% of ped faces or walls coated, distinct; Clear change to -
B2	0.49 - 0.97 m	Yellowish brown (10YR5/4-Moist); Mottles, 10-20%, ; Heavy clay; Moderate grade of structure, 20-50 mm, Prismatic; 0-2%, medium gravelly, 6-20mm, subangular, Shale, coarse fragments; Gradual change to
B3	0.97 - 1.28 m	Grey (10YR6/1-Moist); 20-50%, ; Heavy clay; Massive grade of
