Wealth from Water Site Information Sheet

WfW 0626

Site Information

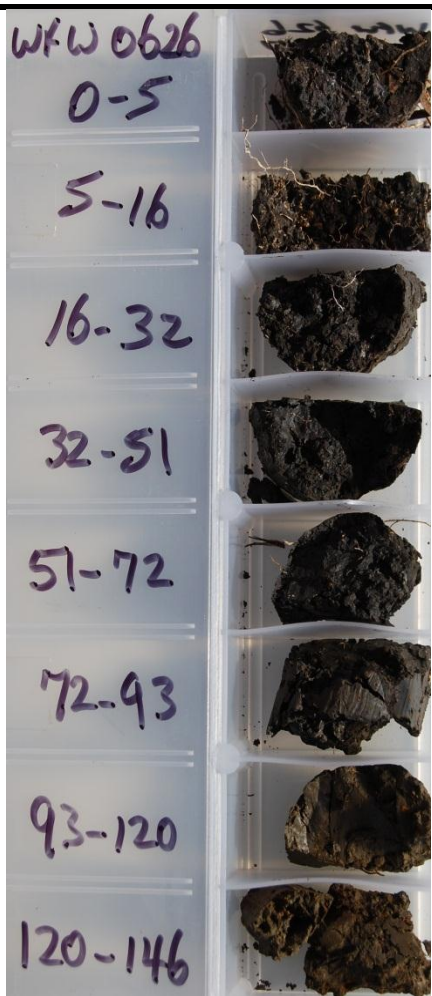
A1	0 - 0.16 m	Black (10YR2/1-Moist); Medium clay; Strong grade of structure, 2-5 mm, Granular; Abrupt change to -
B1	0.16 - 0.51 m	Black (10YR2/1-Moist); Mottles, 0-2%, ; Medium clay; Strong grade of structure, 10-20 mm, Angular blocky; Few cutans, <10% of ped faces or walls coated, faint; Clear change to -
B2	0.51 - 0.92 m	Very dark grey (10YR3/1-Moist); Mottles, 0-2%, ; Medium clay; Strong grade of structure, Prismatic; Common cutans, 10-50% of ped faces or walls coated, distinct; Clear change
B3	0.92 - 1.46 m	Very dark greyish brown (2.5Y3/2-Moist); Mottles, 2-10%, ; Medium clay; Strong grade of structure, Prismatic; Common cutans, 10-50% of ped faces or walls coated,
