Wealth from Water Site Information Sheet

WfW 0694

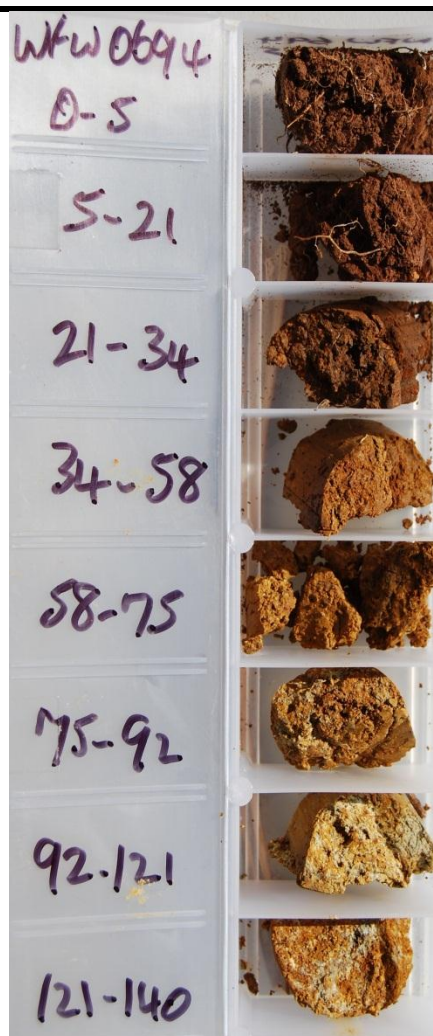
A1	0 - 0.21 m	Dark brown (7.5YR3/4-Moist); Clay loam; Moderate grade of structure, 5-10 mm, Subangular blocky; Clear change to -
A3	0.21 - 0.34 m	Brown (7.5YR4/4-Moist); Mottles, 0-2%, ; Medium clay; Moderate grade of structure, 5-10 mm, Subangular blocky; 0-2%, fine gravelly, 2-6mm, rounded, Quartzite, coarse fragments; Abrupt change to -
B21	0.34 - 0.58 m	Dark yellowish brown (10YR4/6-Moist); Mottles, 2-10%, ; Medium clay; Strong grade of structure, 20-50 mm, Prismatic; 0-2%, fine gravelly, 2-6mm, rounded, Quartzite, coarse fragments; Abrupt change to -
B22	0.58 - 0.92 m	Yellowish brown (10YR5/6-Moist); Mottles, 2-10%, ; Medium clay; Strong grade of structure, 20-50 mm, Prismatic; Gradual change to -
B31	0.92 - 1.21 m	Yellowish brown (10YR5/6-Moist); Substrate influence, 2-10%, ; Medium clay; Massive grade of structure; Clear change to -
B32	1.21 - 1.4 m	Yellowish brown (10YR5/8-Moist); Substrate influence, 2-10%, ; Light clay; Massive grade of structure;
