# Wealth from Water Site Information Sheet

# WfW 0759

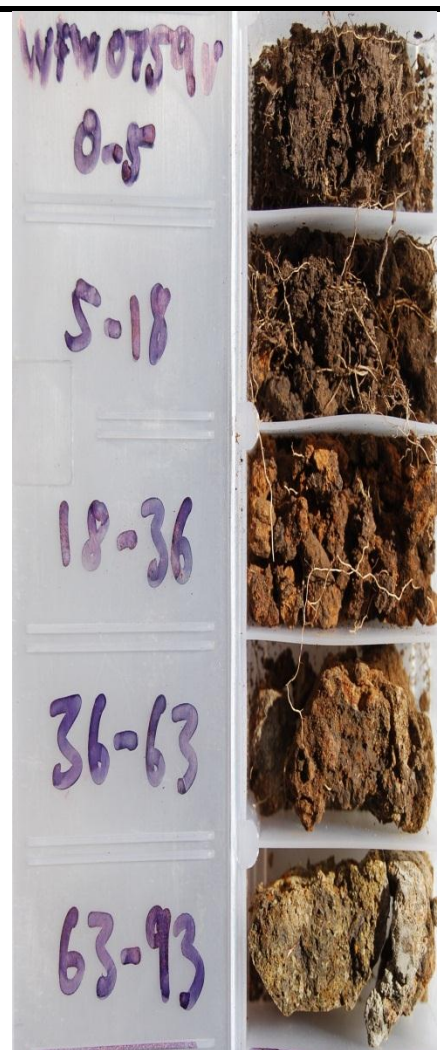
A1	0 - 0.18 m	(/-Moist); Clay loam; Strong grade of structure, 5-10 mm; 0-2%, fine gravelly, 2-6mm, subangular, dispersed, Basalt, coarse fragments;
B1	0.18 - 0.36 m	Dark brown (7.5YR3/2-Moist); Mottles, 2-10%, 5-15mm, Distinct; Light clay; Strong grade of structure, 10-20 mm; 0-2%, fine gravelly, 2-6mm, subangular, dispersed, Basalt, coarse fragments; Clear change to -
B2	0.36 - 0.63 m	Dark grey (7.5YR4/1-Moist); Mottles, 2-10%, 5-15mm, Faint; Light clay; Strong grade of structure, 20-50 mm; 0-2%, coarse gravelly, 20-60mm, subrounded, Basalt, coarse fragments; Clear change to -
B3	0.63 - 0.93 m	Dark greyish brown (2.5Y4/2-Moist); Mottles, 2-10%, 5-15mm, Faint; Light clay; Massive grade of structure; 0-2%, cobbly, 60-200mm, subrounded, Basalt, coarse fragments;
